IL-18 over Illinois River Bridge Replacement Bridge Type Evaluation Henry, Illinois, Marshall and Putnam Counties

Bridge Condition Report

BRIDGE CONDITION REPORT

Structure Number:	062-0036	District: 4				
		Inve	ntory Data			
Facility Carried:	ILL 18	Bridge Name: HENRY BRIDGE		Sufficiency Rating:	6.5 Structure Length:	1719.
Feature Crossed:	ILL RIVER, CROMWELL	Location: 1.22 MI E OF ILL	29	HBP Eligible:	Yes AASHTO Bridge Length:	99.9
Bridge Remarks:				Replaced By:	 Length of Long Span: 	364.3
Bridge Status:	1 OPEN - NO RESTRICT	Status Date: 4/20/2020 12:00:00		Replaces:	- Bridge Roadway Width:	22.6
Status Remarks:	LLO signs verified installed as of 4-20-2	AM 0 NRIS insp		Last Update Date:	03/30/2021 Appr Roadway Width:	36.0
Maint County:	062 MARSHALL	Maint Township: 04 HENR	Y	Parallel Structure:	None Deck Width:	23.3
Maint Responsibility:	10 I.D.O.T.	UNKNOWN	•	Multi-Level Structure Nbr:	Sidewalk Width Right:	0.0
Service On/Under:	1 HIGHWAY	6 / HIGHWAY-WATE	RWAY	Skew Direction: N	None Sidewalk Width Left:	0.0
Reporting Agency:	2 I.D.O.T BUREAU OF LOCA			Skew Angle: 0 D	Navigation Control:	1 Yes

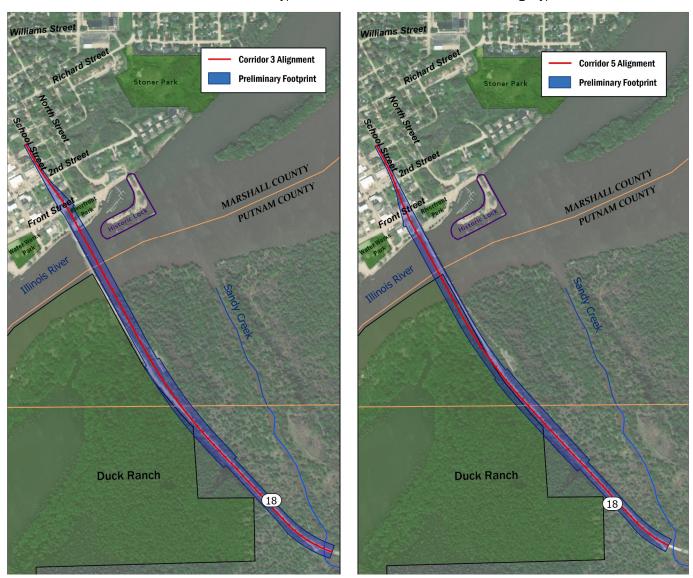
FIGURE 1: CORRIDOR 3 (IMMEDIATELY UPSTREAM OF EXISTING) AND CORRIDOR 5 (IMMEDIATELY DOWNSTREAM OF EXISTING).

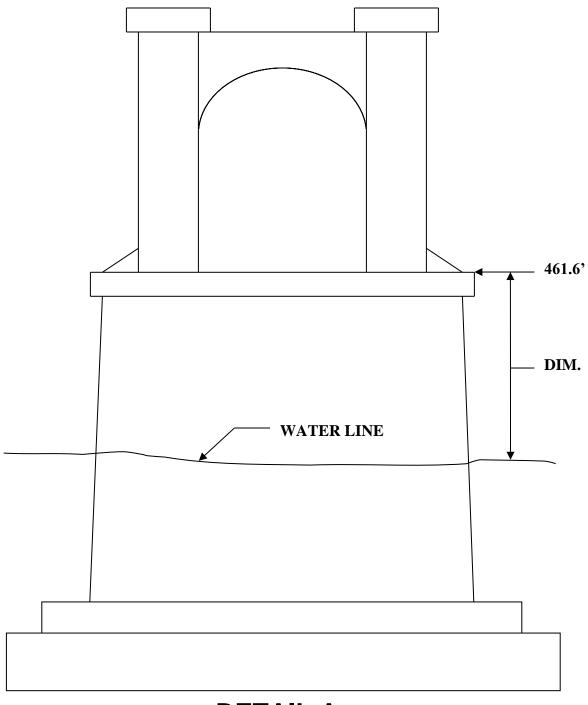
PIER 2

93B2 – Under	rwater Inspection F	Remarks:	
MINOR SCOUR 3'- 4' AROUND F	PIERS. NOTED IN 2	017.		
		Signature		Date
Inspection Team Leader:	Shone &	lumma		04 / 22 / 2020
Consultant Program Manager:				/ /
Agency Program Manager	Steve Nega	ngard		8 / 11/2020

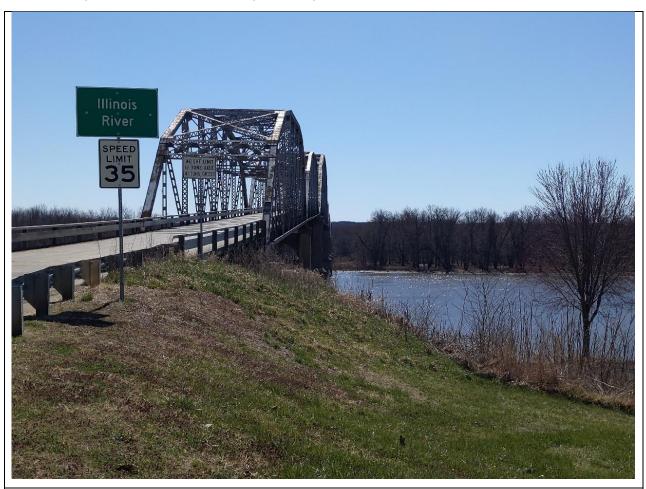
Photo 1 - Looking south from Henry. Approach spans 1 and 2 and truss span 3. Note posting sign restricting bridge to legal loads only.

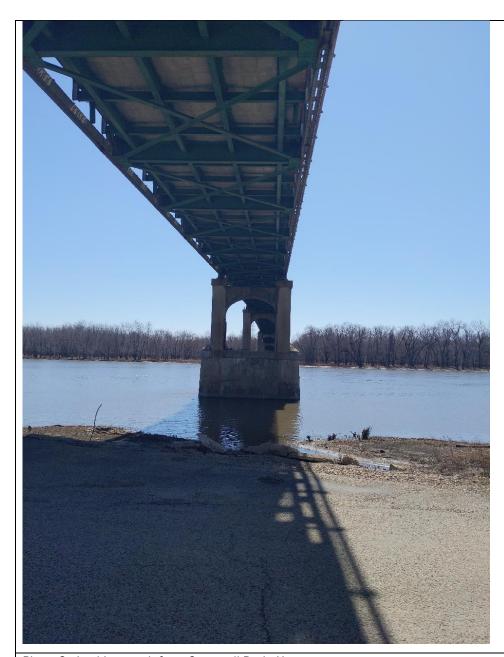
Photo 2 - Looking south from Cromwell Dr. in Henry.

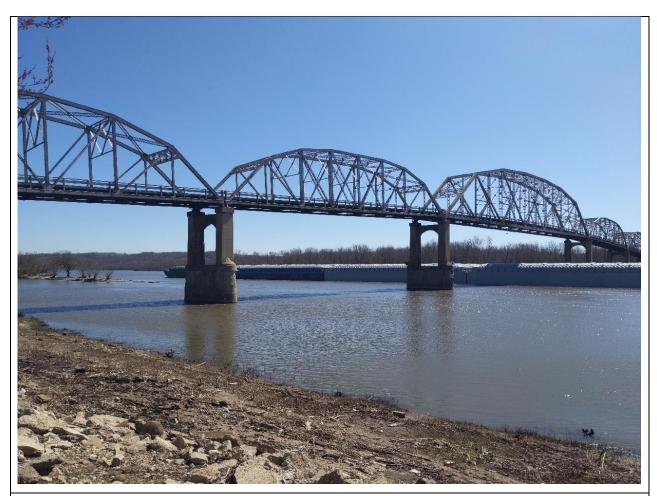
Photo 5 - Looking east. A tow of covered hopper barges being pushed upstream through truss span 5.

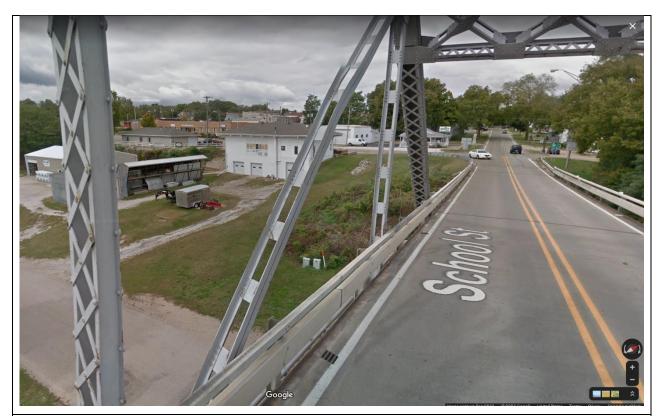
Photo 8 - Looking north. Entering Henry from the bridge.
