IL-18 over Illinois River Bridge Replacement Bridge Type Evaluation Henry, Illinois, Marshall and Putnam Counties

Bridge Condition Report

BRIDGE CONDITION REPORT

Structure Number:	062-0036	District: 4				
		Inve	ntory Data			
Facility Carried:	ILL 18	Bridge Name: HENRY BRIDGE		Sufficiency Rating:	6.5 Structure Length:	1719.
Feature Crossed:	ILL RIVER, CROMWELL	Location: 1.22 MI E OF ILL	29	HBP Eligible:	Yes AASHTO Bridge Length:	99.9
Bridge Remarks:				Replaced By:	 Length of Long Span: 	364.3
Bridge Status:	1 OPEN - NO RESTRICT	Status Date: 4/20/2020 12:00:00		Replaces:	- Bridge Roadway Width:	22.6
Status Remarks:	LLO signs verified installed as of 4-20-2	AM 0 NRIS insp		Last Update Date:	03/30/2021 Appr Roadway Width:	36.0
Maint County:	062 MARSHALL	Maint Township: 04 HENR	Y	Parallel Structure:	None Deck Width:	23.3
Maint Responsibility:	10 I.D.O.T.	UNKNOWN	•	Multi-Level Structure Nbr:	Sidewalk Width Right:	0.0
Service On/Under:	1 HIGHWAY	6 / HIGHWAY-WATE	RWAY	Skew Direction: N	None Sidewalk Width Left:	0.0
Reporting Agency:	2 I.D.O.T BUREAU OF LOCA			Skew Angle: 0 D	Navigation Control:	1 Yes

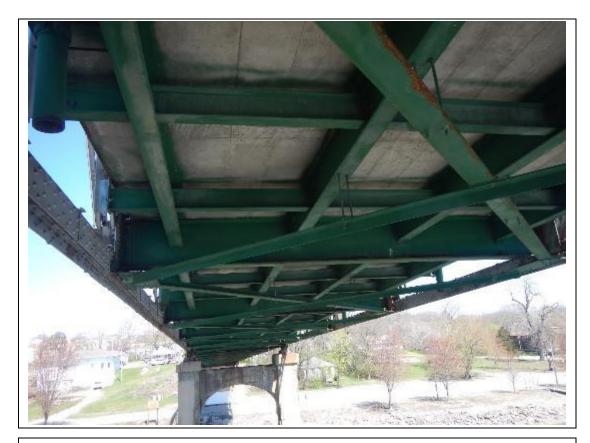
PHOTO 1

SP 4 LOOKING NORTH

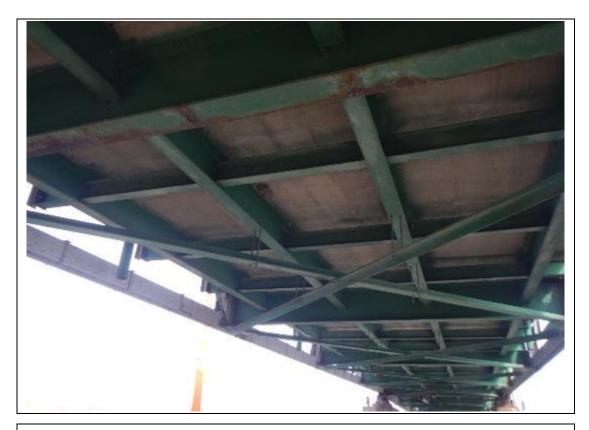
РНОТО 3

SP. 6, LOOKING NORTH

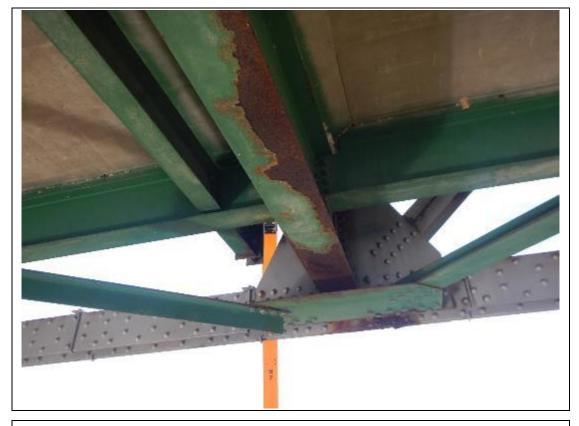
PHOTO 4

SP. 6, LOOKING WEST

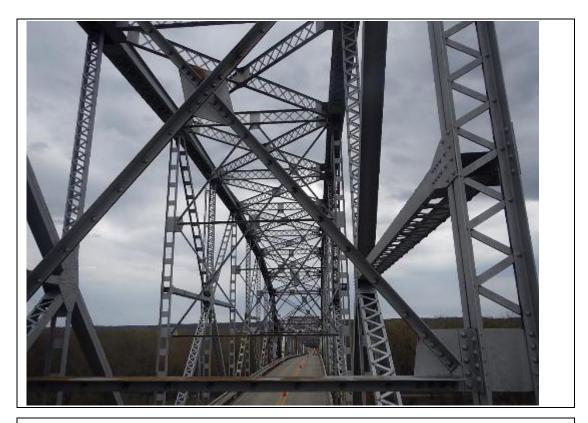
РНОТО 5

SP. 5, LOOKING SOUTH

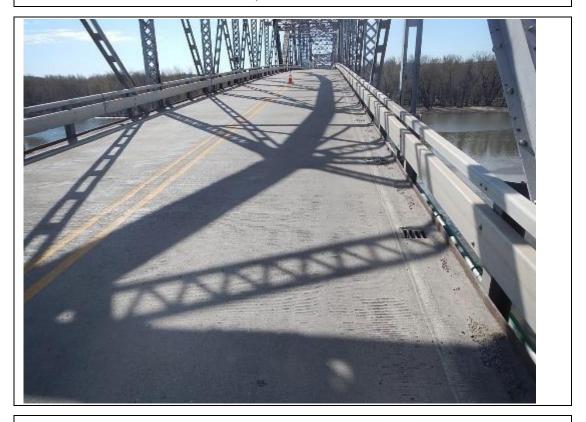
РНОТО 6

SP. 4, LOOKING SOUTH

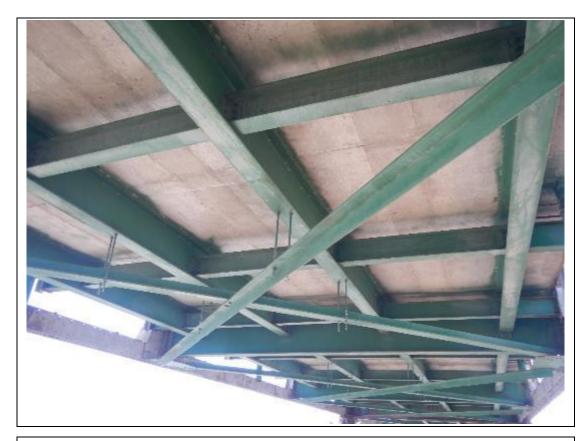
РНОТО 7

SP. 4, LOOKING SOUTH

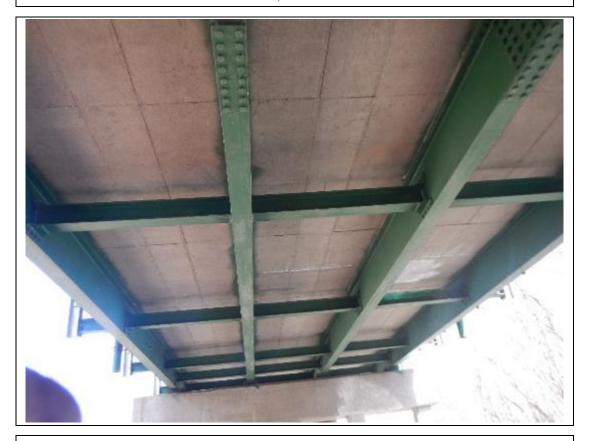
РНОТО 8

SP. 13 LOOKING NORTH

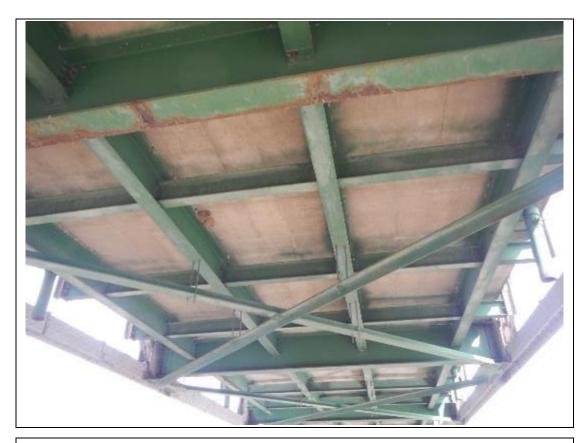
РНОТО 9

SP. 6, LOOKING NORTH

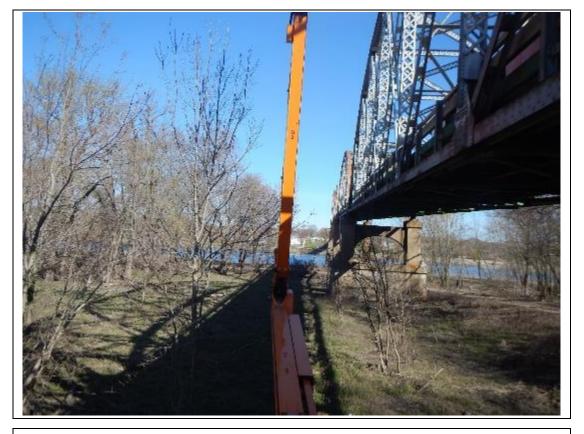
РНОТО 10

SP.7, LOOKING NORTH

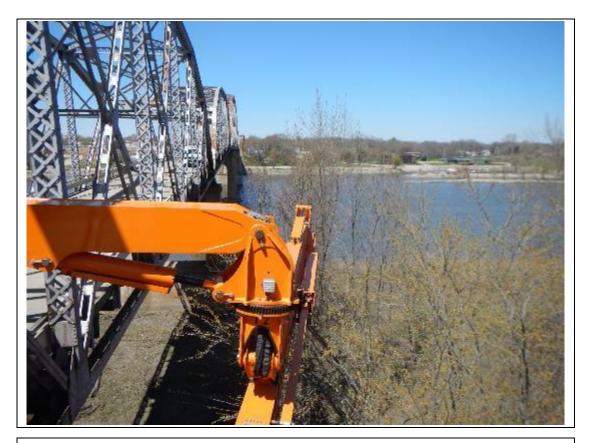
РНОТО 11

SP.8, LOOKING NORTH

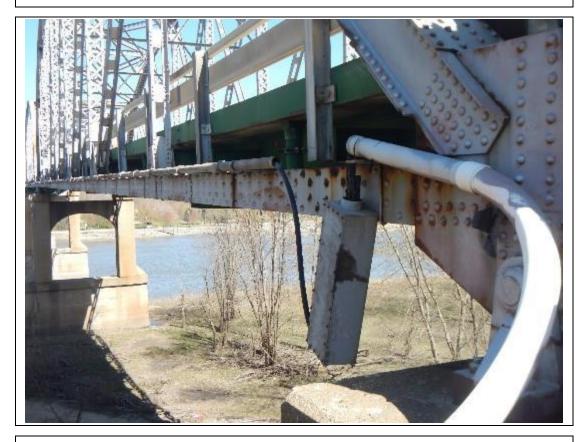
130	7,8	JOINT.	@ P 6	113	3' FAILED	REPAIR	19	X
43	7,8	CONDUIT	P 6, W. SIDE	114	CONDUIT BROKEN IN SEVERAL PLACES, INCLUDING JUNCTION BOX	REPAIR	13	
85	7,8	P6	WALL, COLUMN	115	20 SQ FT SPALL/DELAM WALL 20 SQ FT SPALL/DELAM COLUMN 4 SQ.FT. SPALL/DELAM CAP	MONITOR	17	
131	8	FB. 0	FULL LENGTH TO COVER PL.	112, 117	14% S.L., BOT. FLG. 4% S.L., TOP FLG. (SEE DETAIL 25)	REPAIR		
44	8	L0E – L1E	@ L0E	118	26% S.L. (SEE DETAIL 4)	REPAIR2

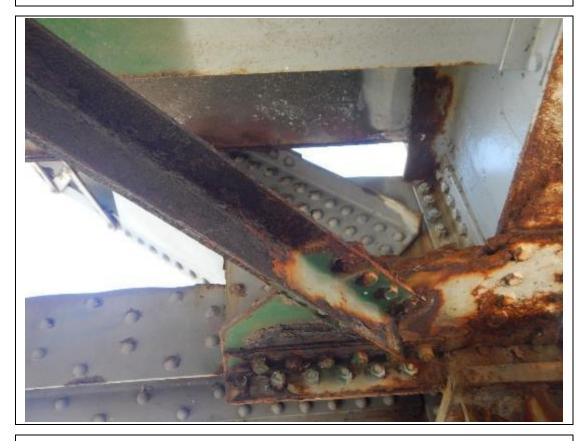
* See report from year indicated for photo of deficiency								
ITEM #	SPAN	MEMBER	LOCATION	РНОТО	DEFICIENCY	RECOMMENDATION BY SPN	YR	СН	
132	8	L0E – U1E	@ L0E, & 4' ABOVE L0E	119	LACING BARS 1-12 FROM BOT. CHORD HAVE 1"- 3" HOLES, MOST 100% S.L., 2 BARS BROKEN	MONITOR	19		
133	8	L0W-L1E	@ L0W	120	20% S.L., 12'' X 2'' HOLE IN CONN. PL.	MONITOR	19		
45	8	PORTAL FRAME	U1W U1E, 2' WEST OF CENTERLINE OF ROADWAY	* 2015	10" X 1" OFFSET	REPAIRED	07		
134	8	L1E-L2W	@ L2W	121	20% S.L., 7" X 2" HOLE IN CONN. PL.	MONITOR	19		
66	8	L2E – L3W	@ L3W	122	10%S.L., 5" X 2" HOLE IN BOT. CONN PL.	MONITOR	15		
135	8	L3E – U4E	2' FROM L3E	?	4% S.L., (SEE DETAIL 3)	MONITOR	19		
86	8	L3W-U4W	@ L3W	123	8% S.L., (SEE DETAIL 3)	MONITOR	17		
67	8	L3E – L4W	@ L4W	124	20% S.L., 4" X 7" & 2-1" HOLES IN BOT. CONN PL.	MONITOR	15		
68	8	GUSS. PL	@ L4W, O.S. PL.	125	5% S.L., .488" AVG REM. IN 12" X 3"AREA, & .625"NOM. (PL. 52"W X 5/8" THICKNESS)	MONITOR	15

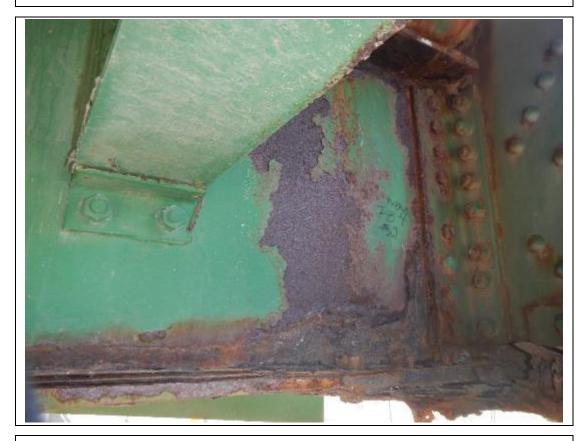
PHOTO 126

154	8	FB. 4	W END	126	15% S.L. IN WEB, 20% S.L. IN BOT. FLG. (SEE DETAIL 27)	MONITOR	20	X	
136	8	L4W – U5W	2' FROM L4W	127	5% S.L., .23 AVG REM INT. LEGS, 5/16" NOM.	MONITOR	19		
69	8	L4E – L5W	@ L5W	128	20% S.L., 4"L X 10" HOLE IN BOT. CONN PL.	MONITOR	15		
137	8	FB. 5	W. END	129	8% S.L., BOT. FLG. @ L5W CONN. PL., .695" REM., .85 NOM.	MONITOR	19		
70	8	U5E – U6W	@ MIDSPAN, PAN 6	130	14% S.L. 7/8" MISDRILLED HOLE	MONITOR	15		
46	8	L6W - U7W	20' ABOVE DECK	?	9" x ½" OFFSET	MONITOR	03		
87	8	L7W U7W	@ L7W, 8" ABOVE GUSSET	131	26% S.L. (SEE DETAIL 11)	REPAIRED 29% S.L., IRF= 0.63	17	X	
71	8	U7W – L8W	@ L8W, & 4' ABOVE L8W	132	30% S.L., 10" X 3"L & 2"L X 3" HOLES IN BATTEN PL., & LACING BARS 2-9 FROM BOT. CHORD HAVE 1"- 3" HOLES, MOST 100% S.L., 4 BARS BROKEN	MONITOR	15

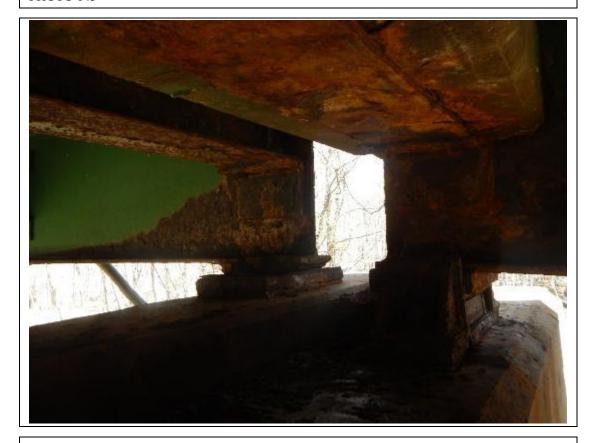
PHOTO 144

88	11	BEAM 1	@ BENT 5	144	27% S.L. WEB BRG. (SEE DETAIL 9)	REPAIR 19% S.L. WEB BRG., IRF=1.62	17		
146	11	DIAPH.	@ BENT 5 BTWN. BM. 1 & 2	145	WEB OF DIAPH. BUCKLED @ BM. 1	REPAIR	19		
89	11	BEAM 2	@ BENT 5	146	16% S.L. (SEE DETAIL 9)	REPAIR 17% S.L., IRF=1.49	17		
90	11	BEAM 3	@ BENT 5	147	9% S.L. (SEE DETAIL 9)	MONITOR 9% S.L., IRF=1.54	17		
91	11	BEAM 4	@ BENT 5	148	14% S.L. (SEE DETAIL 9)	RATE	17	X	
92	12	BEAM 1	@ BENT 5	144	45% S.L. (SEE DETAIL 9)	REPAIR 27% S.L., IRF=1.48	17		
93	12	BEAM 2	@ BENT 5	146	29% S.L. (SEE DETAIL 9)	REPAIR 14% S.L., IRF=1.38			
94	12	BEAM 3	@ BENT 5	147	41% S.L. (SEE DETAIL 9)	REPAIR 10% S.L., IRF= 1.33	17

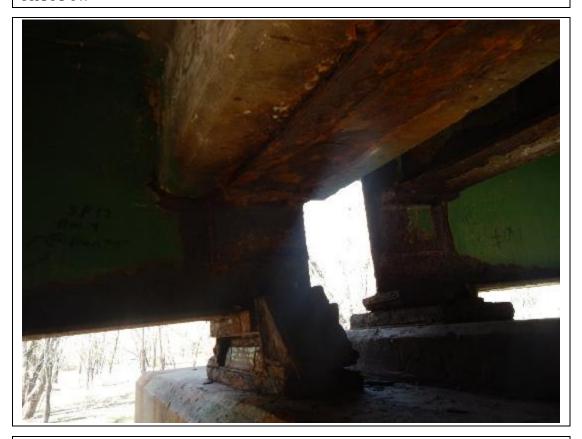
PHOTO 148

ITEM #	SPAN	MEMBER	LOCATION	РНОТО	DEFICIENCY	RECOMMENDATION BY SPN	YR	СН
95	12	BEAM 4	@ BENT 5	148	18% S.L. (SEE DETAIL 9)	RATE 8% S.L., IRF= 1.36	17	X
48	11, 12	BENT 5	ALL PILES	149, 150	25% S.L. PILE VERT. BARS 100% S.L. TIES 30% S.L. PILE CONCRETE (SEE DETAIL 6)	REPAIR	05	X
50	12, 13	BENT 6	PILE 2, & PILE 3 (PILES NUMBERED FROM EAST TO WEST)	155	19% S.L., 6 SQ. FT. DELAM./SPALL W/ EXP. BARS ON PILE 2, & 6 SQ. FT. DELAM./SPALL W/ EXP. BARS, 2 VERT. EXP. & 1 TIE ON PILE 3 (SEE DETAIL 8)	MONITOR	09	X
51	14	JUNCTION BOX	@ S. ABUT., E. SIDE	156	NO COVER ON BOX, CONDUIT BROKEN	REPAIR	13	
52	14 APPROACH © S. ABUT.		157	24 SQ. FT. DELAM./ SPALL	REPAIR	09	X

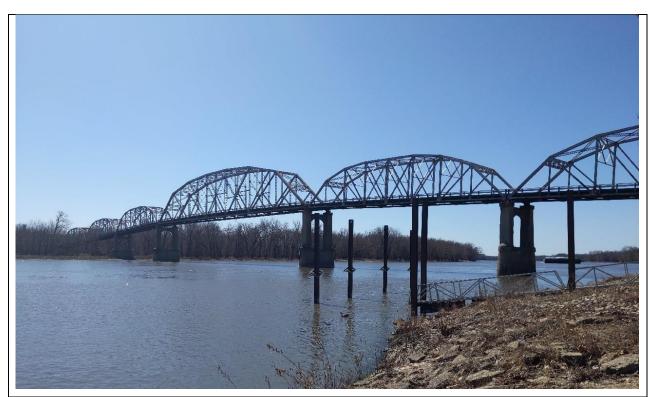
Photo 2 - Looking south from Cromwell Dr. in Henry.

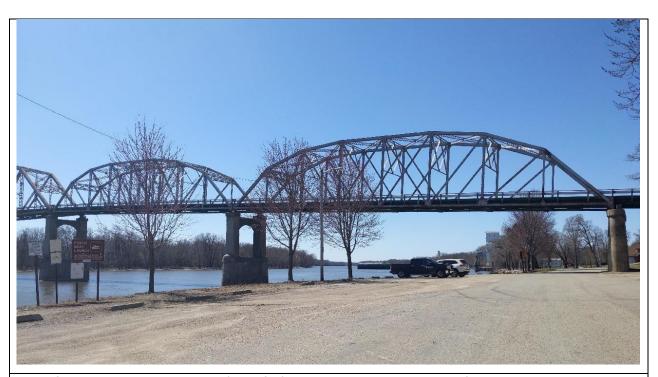
Photo 3 - Looking west. Spans 3 (partial at right), 4, 5 (navigation), and 6 leading into the trees on the south bank at left.

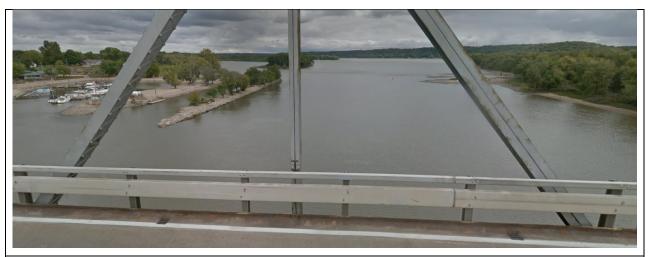
Photo 5 - Looking east. A tow of covered hopper barges being pushed upstream through truss span 5.

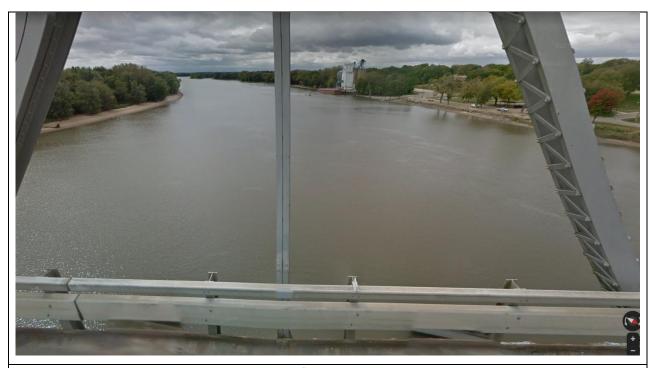
Photo 6 - Looking east (upstream). Abandoned lock from former dam at left, Henry marina at far left.
